# Water Compliance Inspection Report

**National Pollutant Discharge Elimination System  
(NPDES)  
Inspection Report**

**Nu-West Industries, Inc./Rasmussen Ridge Mine  
(DBA Agrium Conda Phosphate Operations)  
Soda Springs, Idaho**

**Inspection date: September 6, 2012  
Report completion date: October 30, 2012**

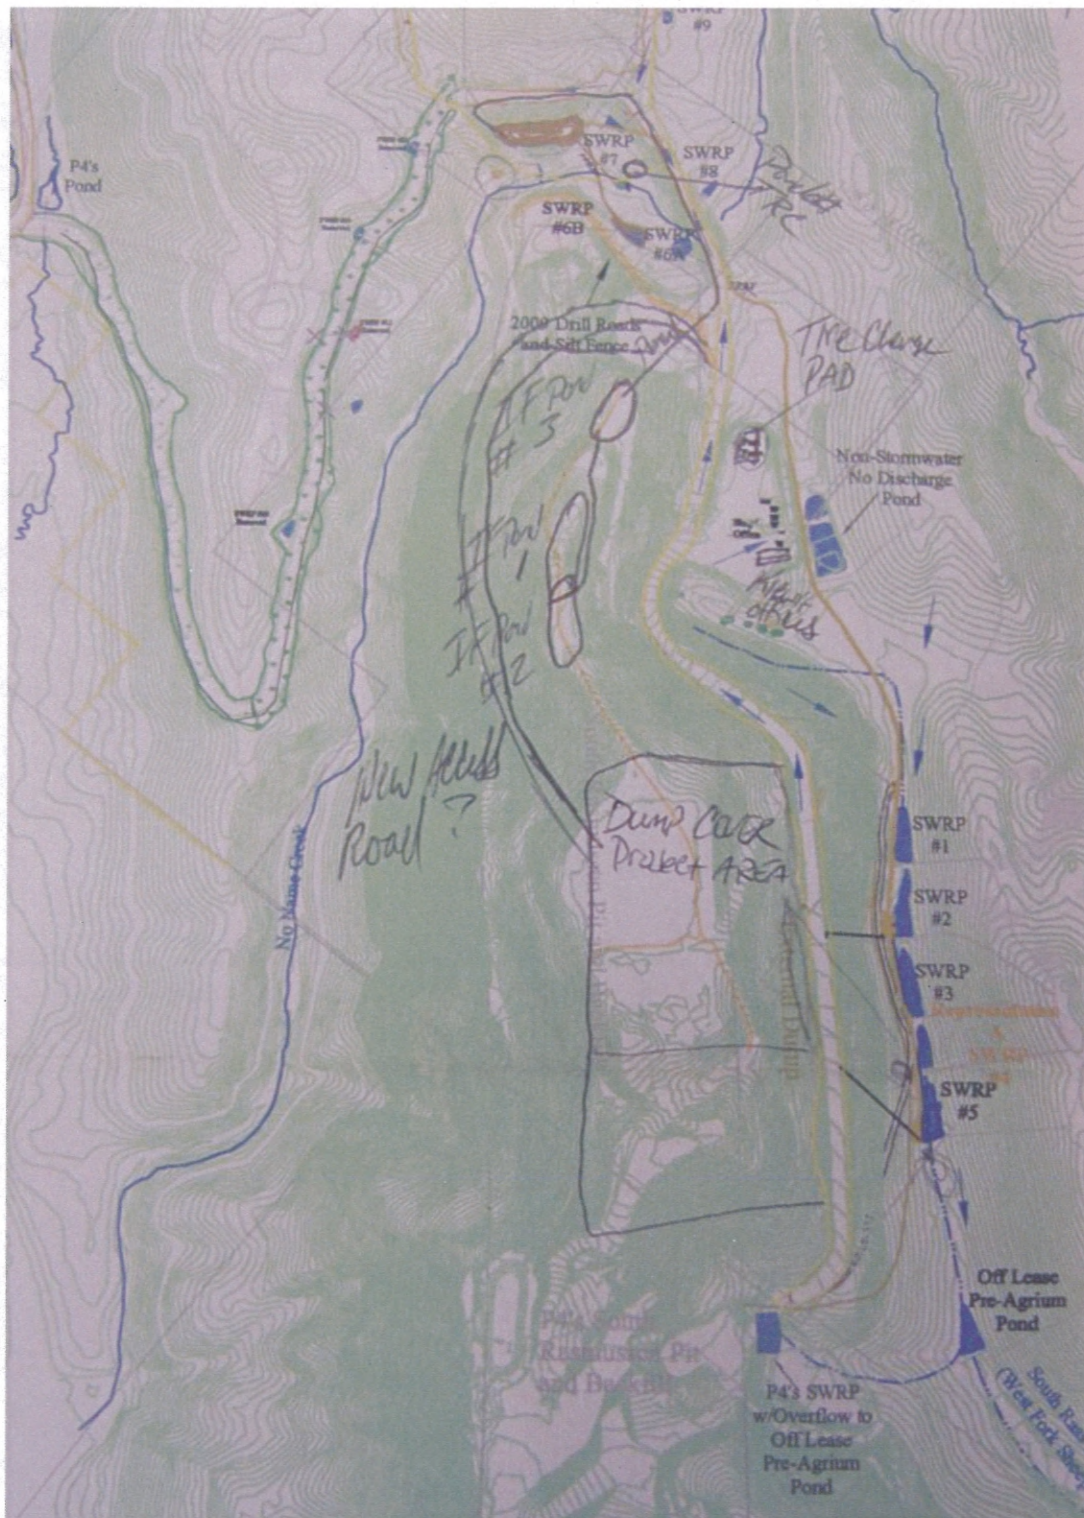
Figure 2  
Details from the SWPPP site map in use at the time of this inspection.

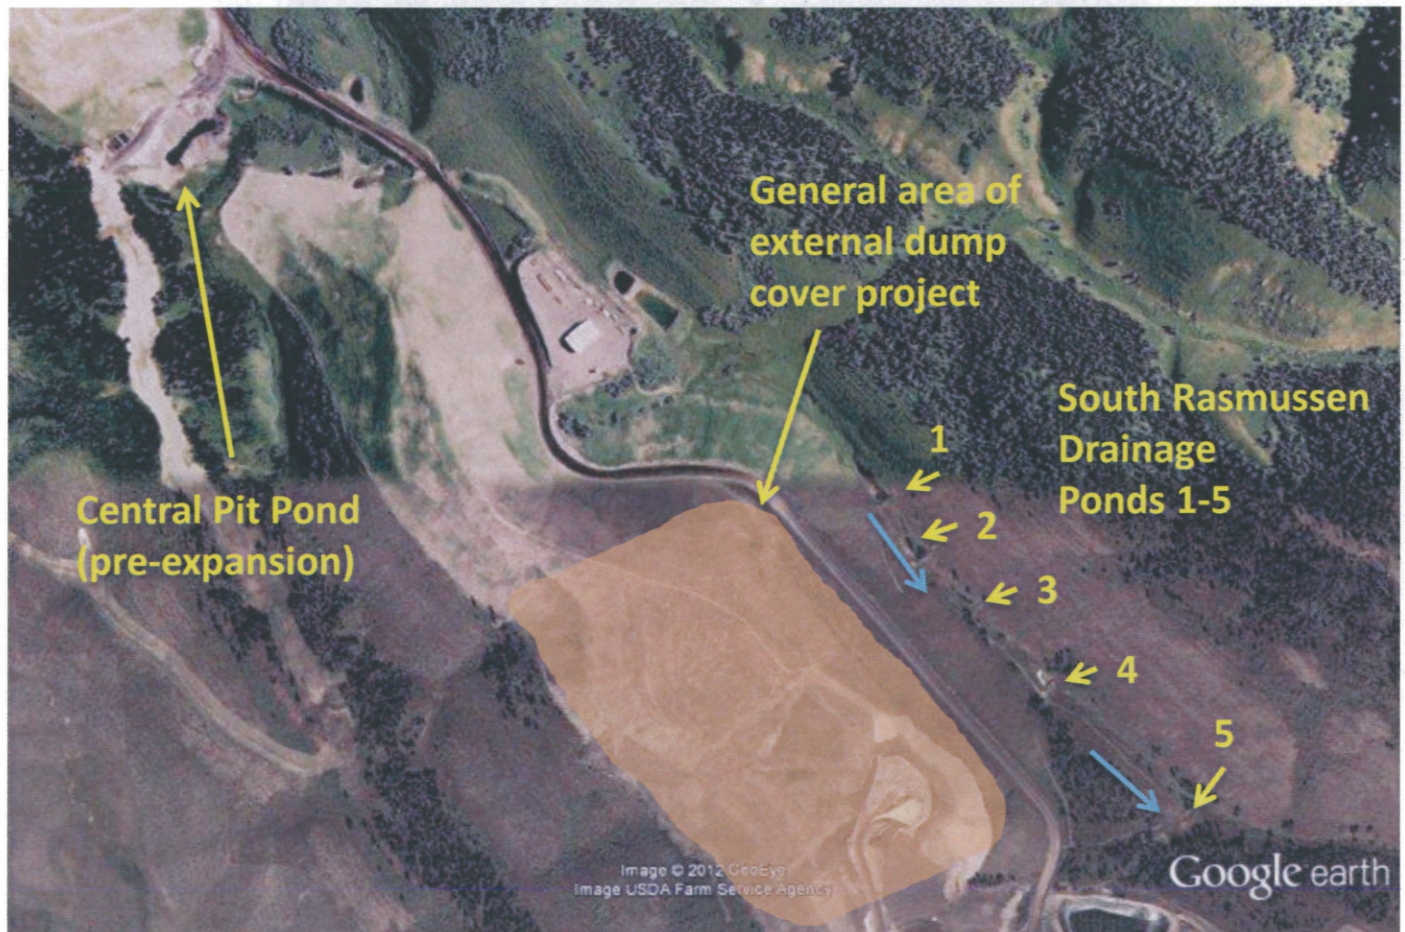
Figure No. 3  
Google Earth photo with some mine features identified. Image date: 8/19/2010.

ponds" within the South Rasmussen Drainage to collect and manage the discharges from the dump as well as stormwater from adjacent surface areas (Ponds 1-5; Figure 3, page 15 and Photos 1-13, pages 16-22). In theory, the ponds were intended to serve as a mitigation measure designed to eliminate any unpermitted discharge to the waters of the United States. In 2005, Nu-West conducted sampling and analysis of the water in the South Rasmussen Drainage ponds in response to a 308 request from EPA. The detection of selenium at levels in excess of the Idaho Water Quality Standards prompted EPA to issue of a Notice of Violation (NOV) to Nu-West in February 2006. The NOV required Nu-West to conduct additional site sampling and analysis and to develop a plan to prevent any further discharges to South Rasmussen Drainage. During this inspection, Dave Tomten pointed out that it is a misnomer to refer to these ponds as "stormwater" ponds since they also use to collect and retain an industrial discharge; i.e., the discharge from the toe of the exterior dump.

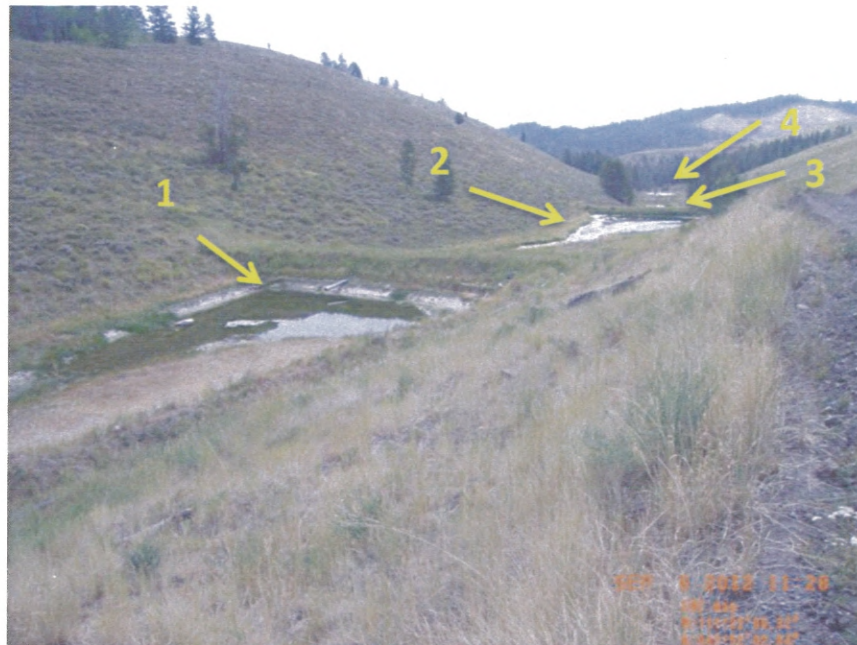
Photo No. 1 (R0011488)

Stormwater/mine water retention ponds in South Rasmussen Drainage  
(east of and below the external overburden dump); Pond 5 is out-of-view.

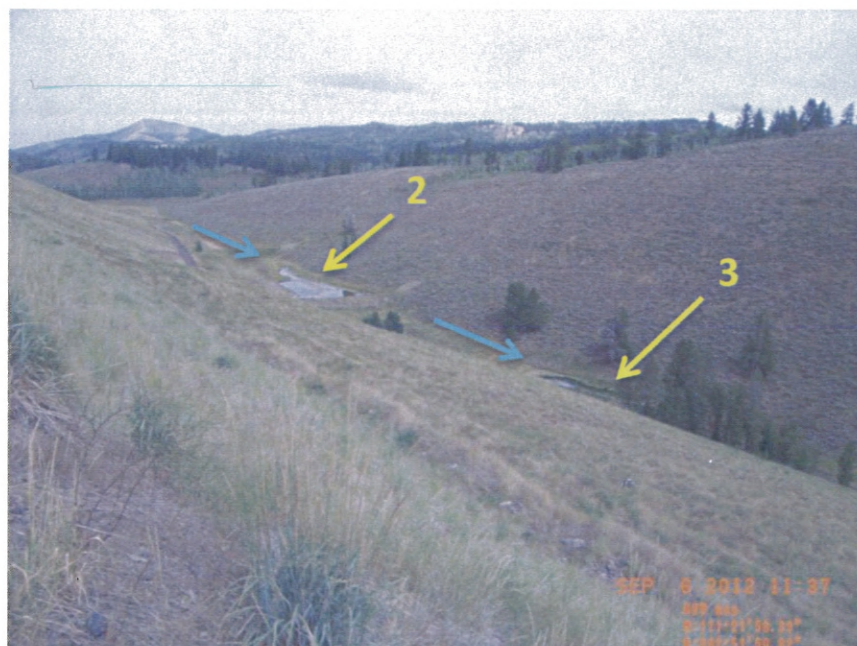
Photo No. 2 (R0011489)

Stormwater/mine water retention ponds in South Rasmussen Drainage  
(east of and below the external overburden dump); Ponds 2 and 3.

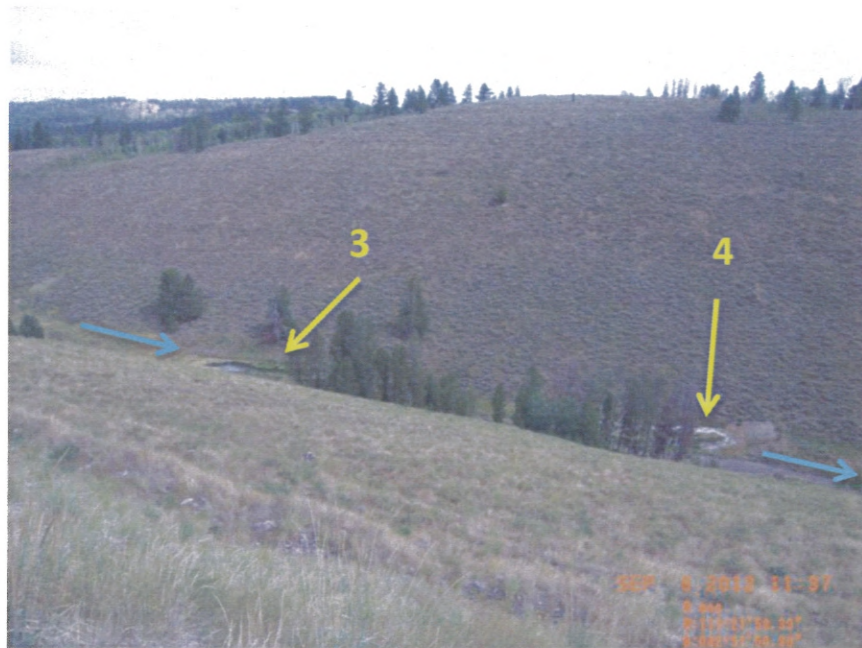
Photo No. 3 (R0011490)  
Stormwater/mine water retention ponds in South Rasmussen Drainage  
(east of and below the external overburden dump); Ponds 3 and 4.

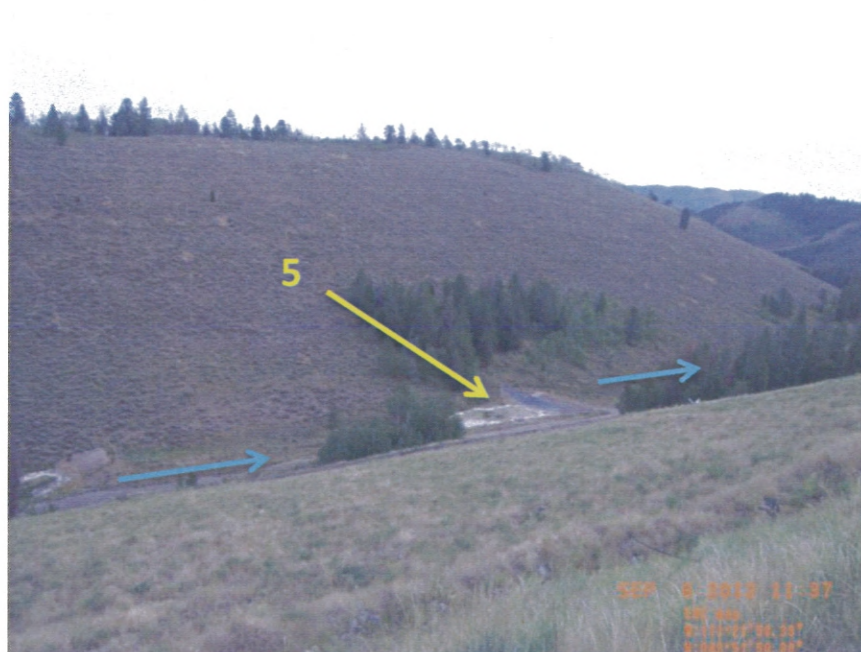
Photo No. 4(R0011492)  
Stormwater/mine water retention ponds in South Rasmussen Drainage  
(east of and below the external overburden dump); Pond 5.

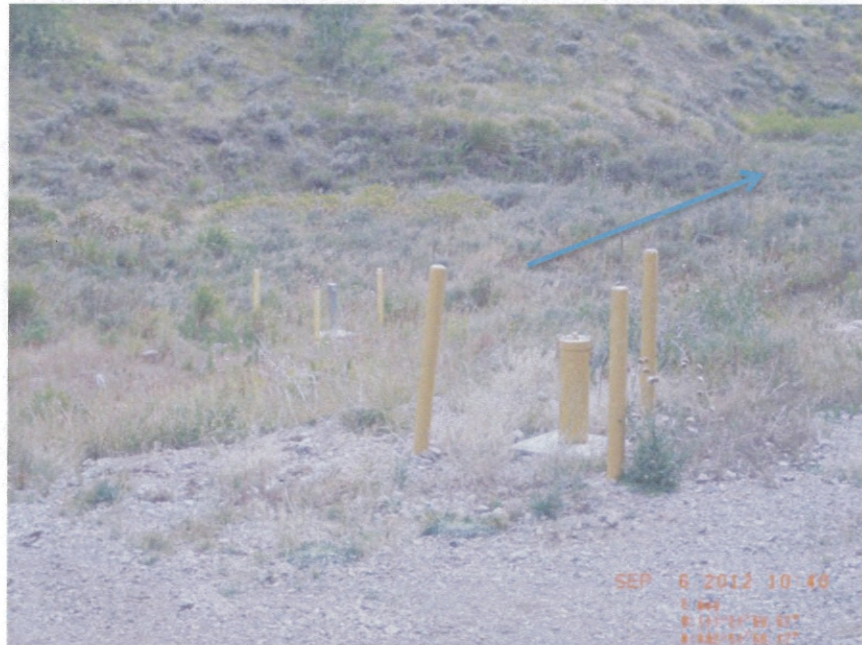
Photo No. 5 (R0011475)  
Monitoring well below Pond 5 in South Rasmussen Drainage. The presence of selenium in groundwater samples collected from this well in 2011 suggest there may be an alluvial discharge from Pond 5 or above.

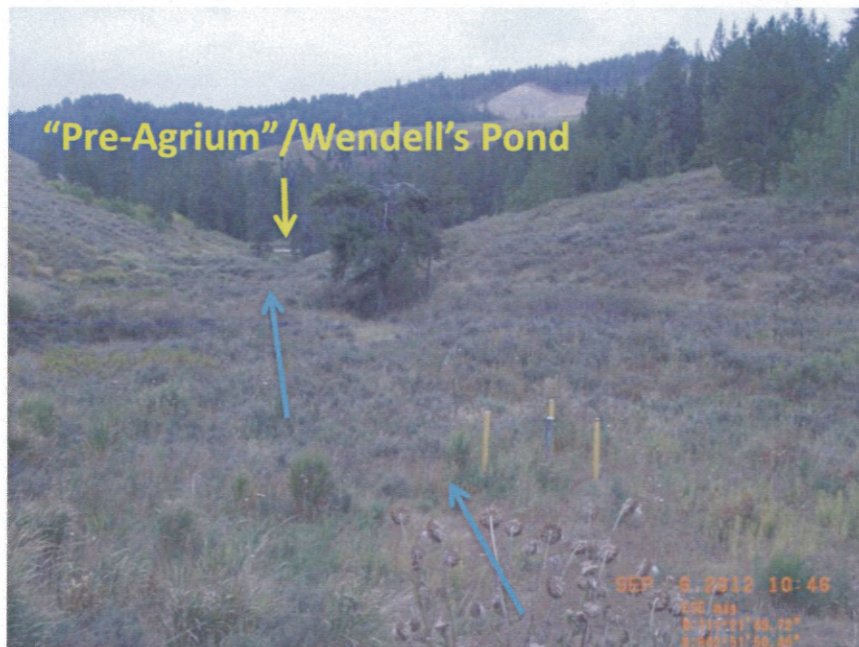
Photo No. 6 (R0011481)  
Piezometer below Pond 5; "Pre-Agrum"/Wendell's Pond in background. Selenium levels above the Idaho Water Quality Standards were detected in water samples from the Pre-Agrum Pond in 2011.

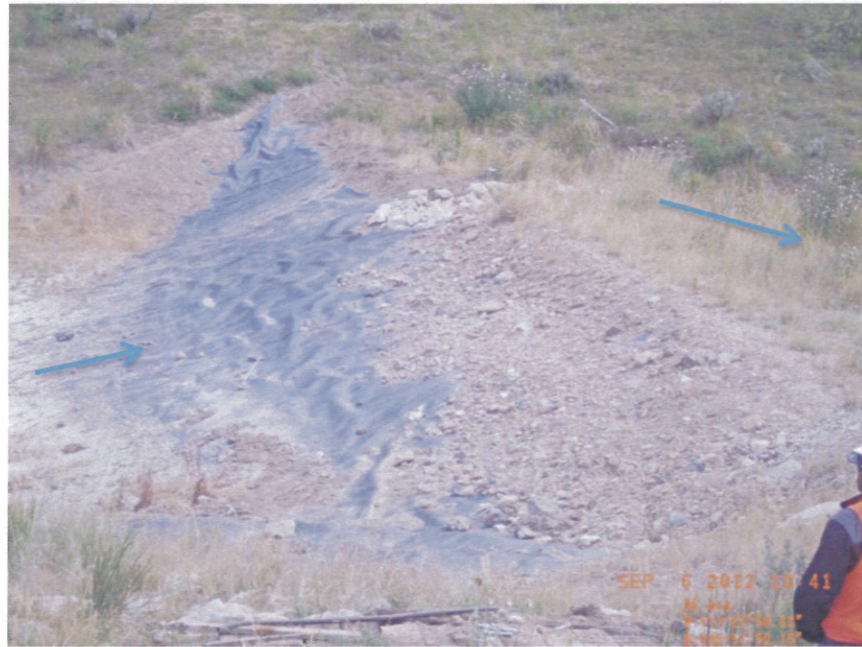
Photo No. 7 (R0011477)  
South Rasmussen Drainage; upstream side of Pond 5 dam; lined on face only.

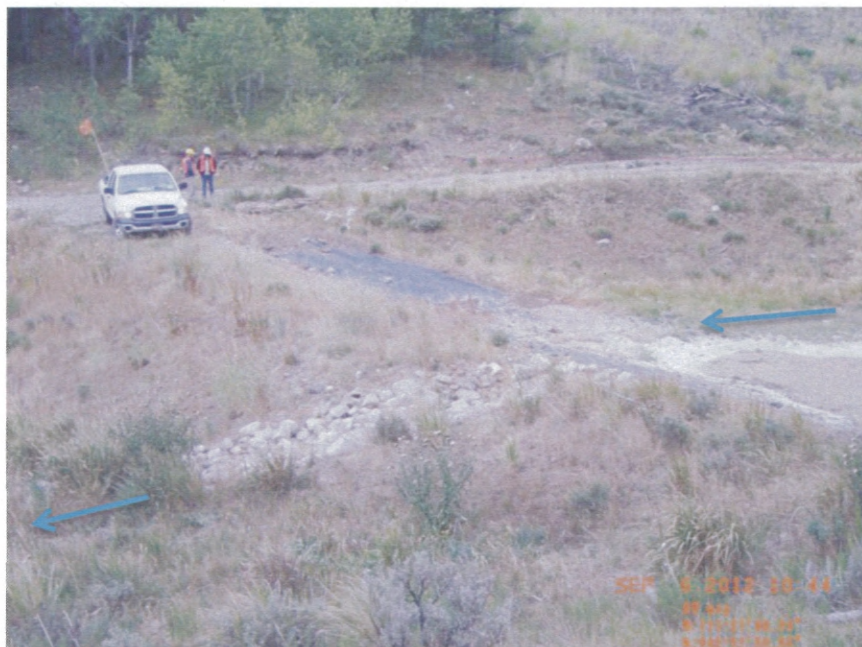
Photo No. 8 (R0011478)  
South Rasmussen Drainage; downstream side of Pond 5 dam.

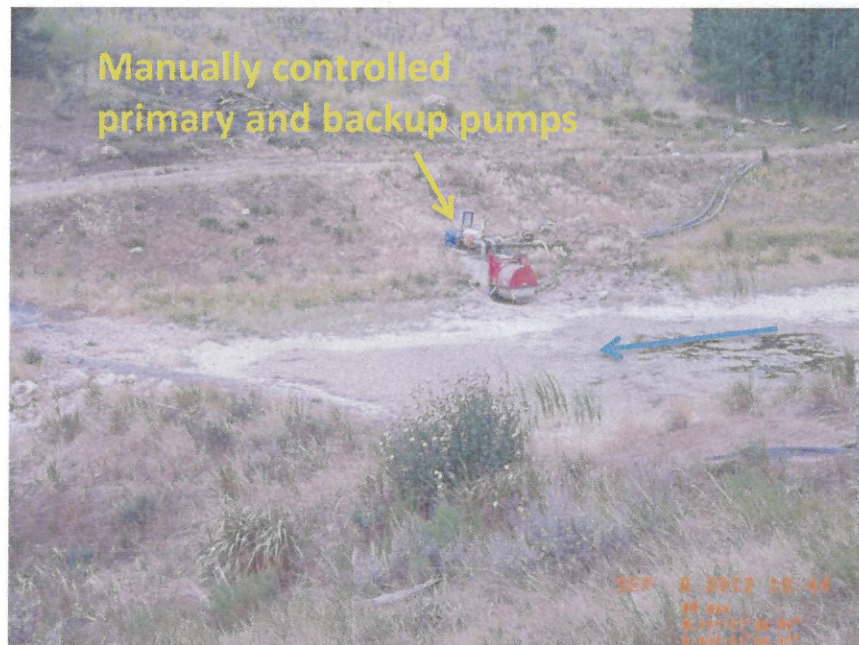
Photo No. 9 (R0011479)  
South Rasmussen Drainage; Pond 5. Pumps are used to pump water from Pond 5 to Pond 2 when necessary.

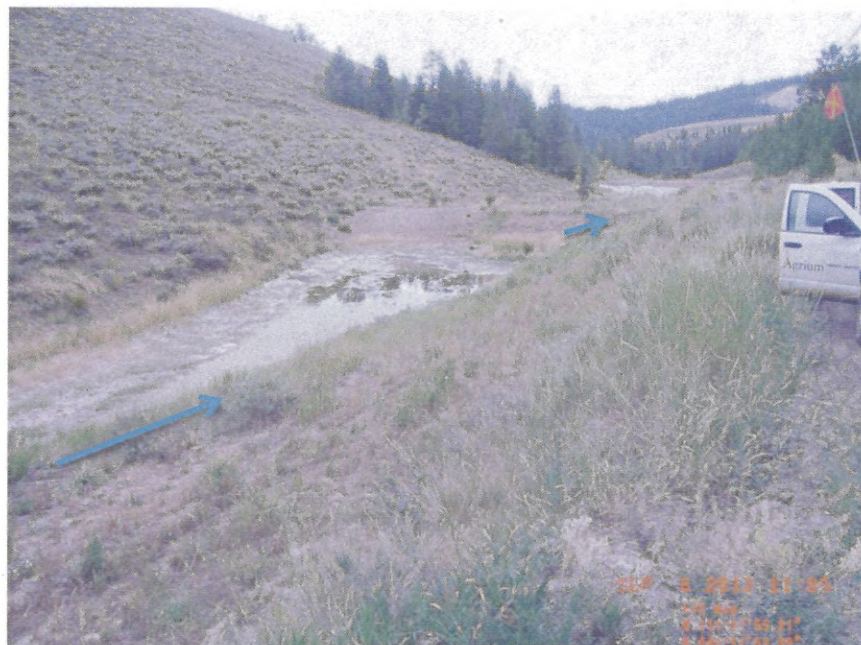
Photo No. 10 (R0011482)  
South Rasmussen Drainage; Pond 4 (on left) and Pond 5.

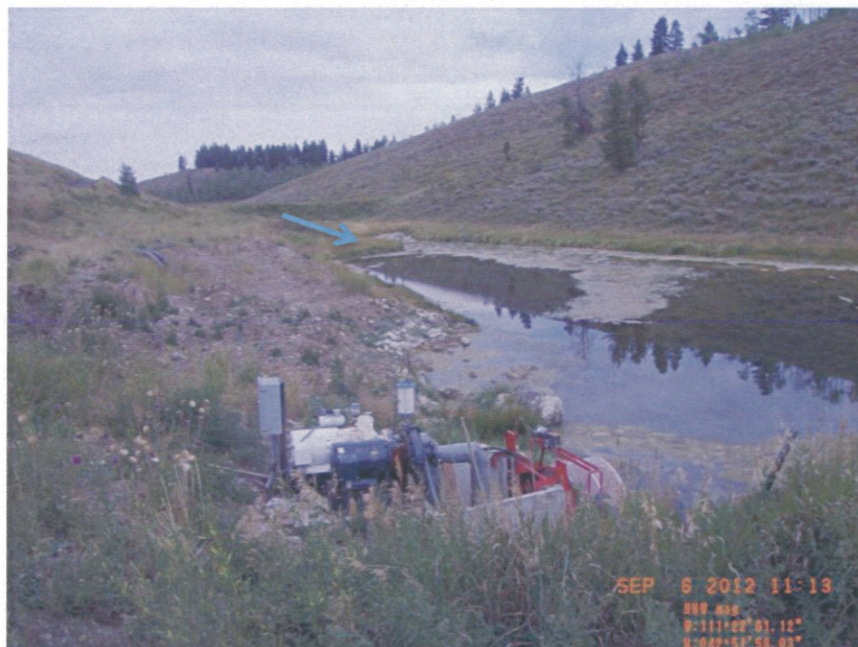
Photo No. 12 (R0011485)  
South Rasmussen Drainage; manually operated pumps used to  
transfer water from Pond 2 to the Central Pit Pond.

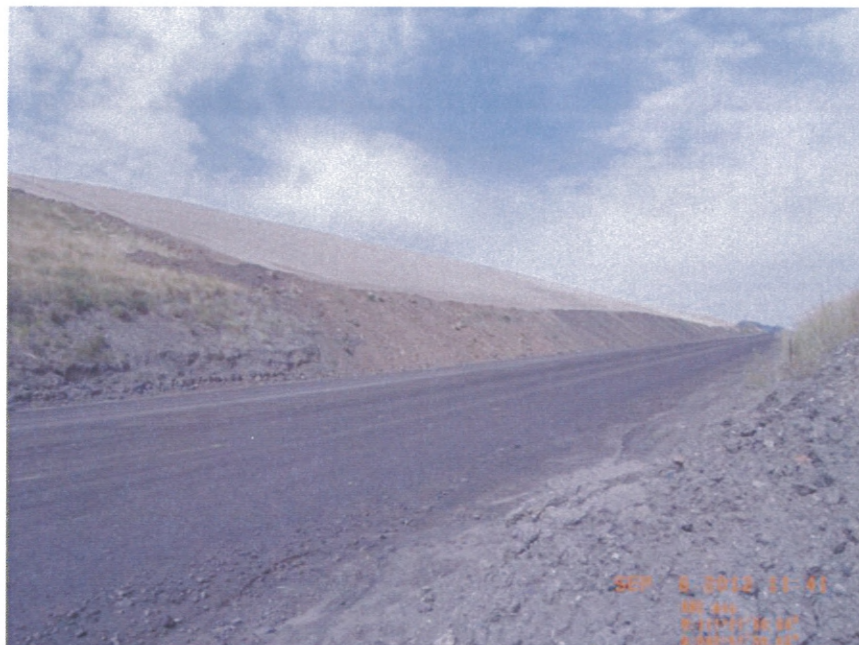
Photo No. 14 (R0011494)  
Haul road along the base of the external dump. The smooth, graded soil on the slope has been prepped for the installation of the geosynthetic clay liner (GCL) pilot project.

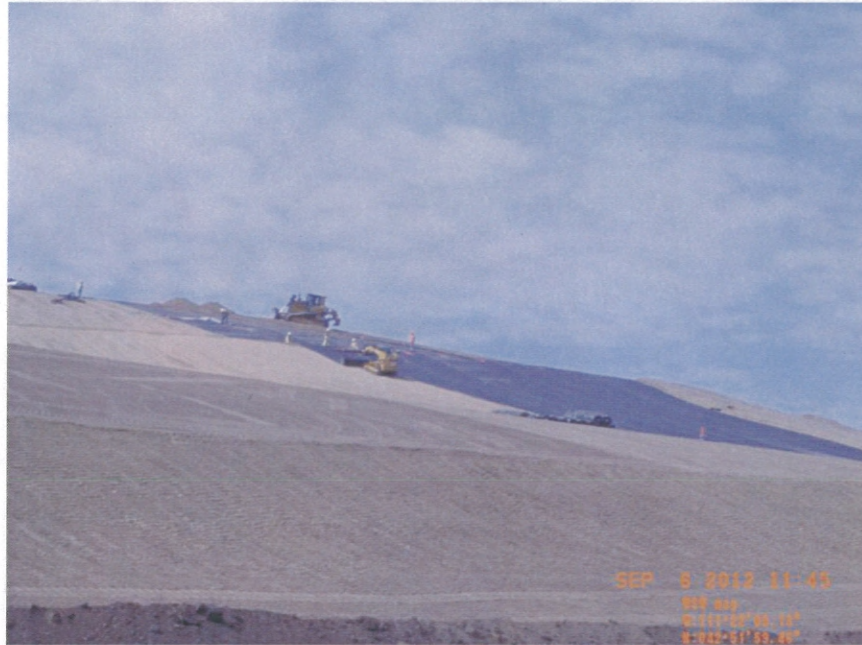
Photo No. 15 (R0011496)  
South Rasmussen external dump cover pilot project; installation of the GCL.

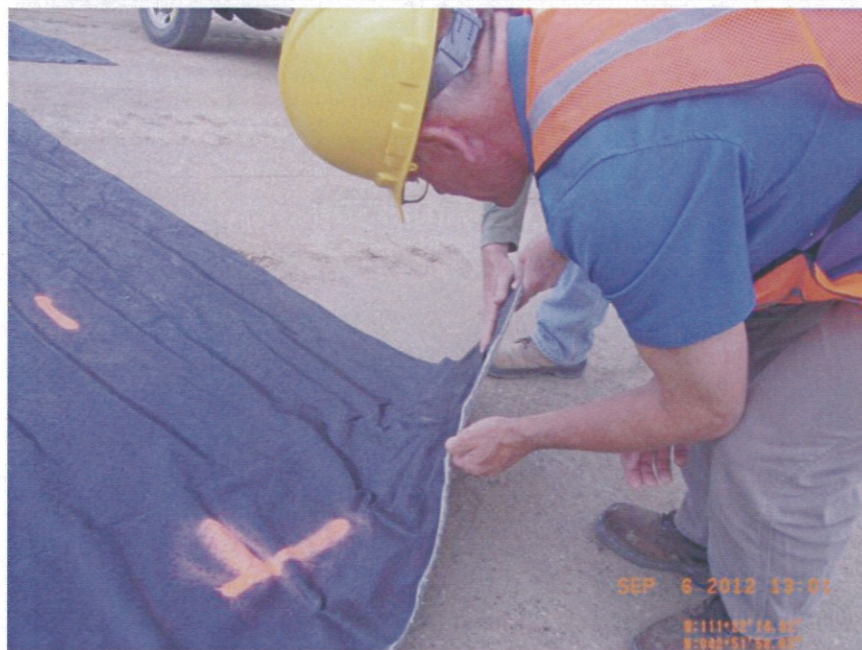
Photo No. 16 (R0011501)  
South Rasmussen external dump cover pilot project; detailed look at the GCL.

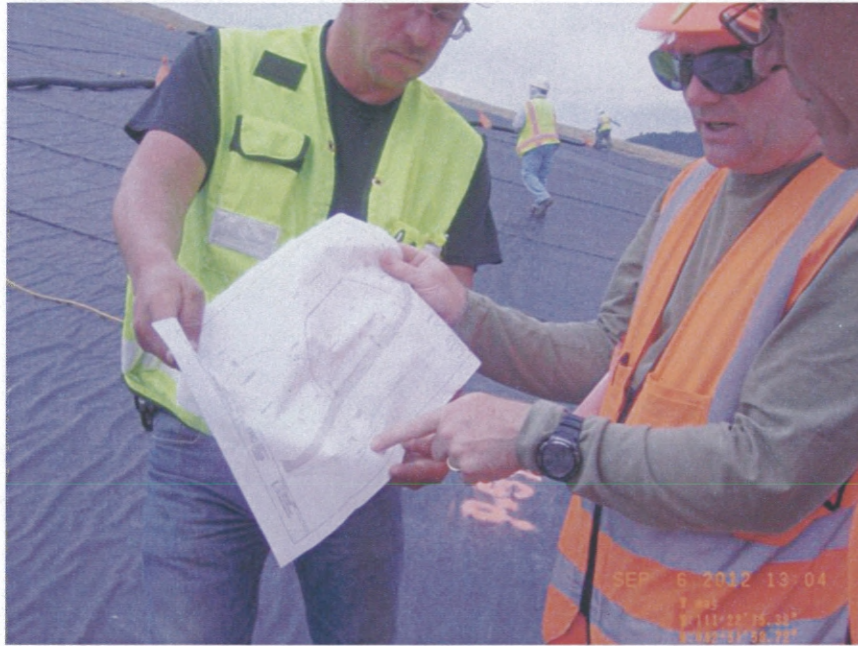
Photo No. 17 (R0011504)  
South Rasmussen external dump cover pilot project; reviewing the design plans for the installation of the GCL.

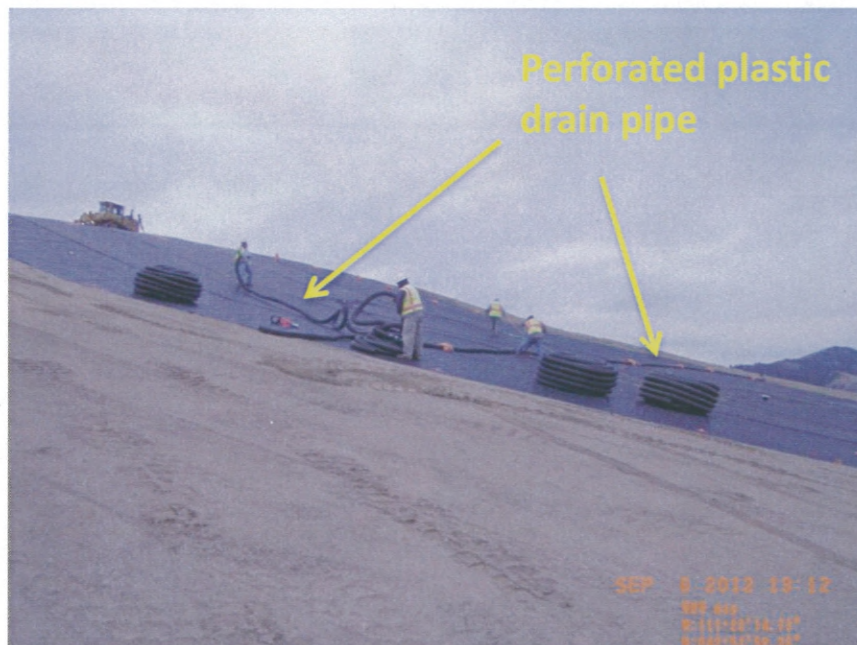
Photo No. 18 (R0011506)  
South Rasmussen external dump cover pilot project and the installation of the above-liner stormwater collection system. All stormwater collected from the dump surface will drain to a culvert passing under the haul road with discharge to Pond 5. If regulated constituents are below Idaho Water Quality Standards, the water will then be discharged to the South Rasmussen drainage.

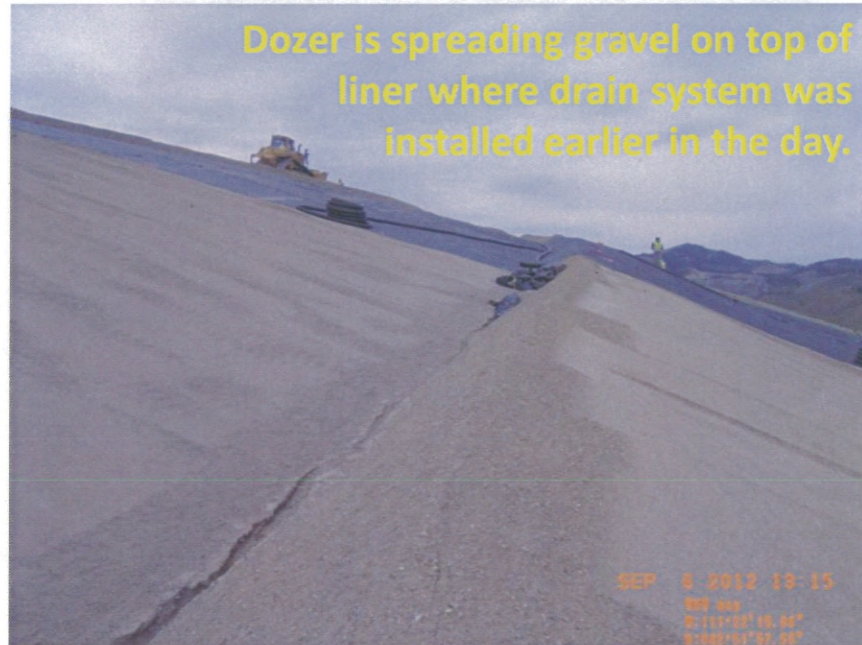
Photo No. 19 (R0011507)

South Rasmussen external dump cover pilot project and the installation of the liner and the above-liner stormwater collection system. As part of the pilot project, half of the liner will be covered with washed gravel and half with larger angular rock before final placement of the soil and vegetative cover cap.

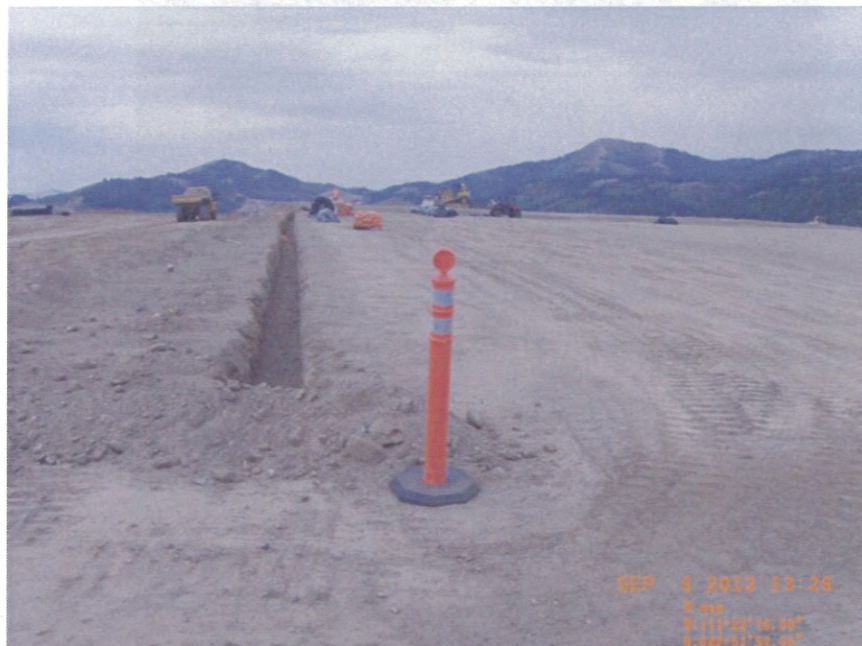
Photo No. 20 (R0011508)

South Rasmussen external dump cover pilot project; the key trench used to anchor the top of the GCL.

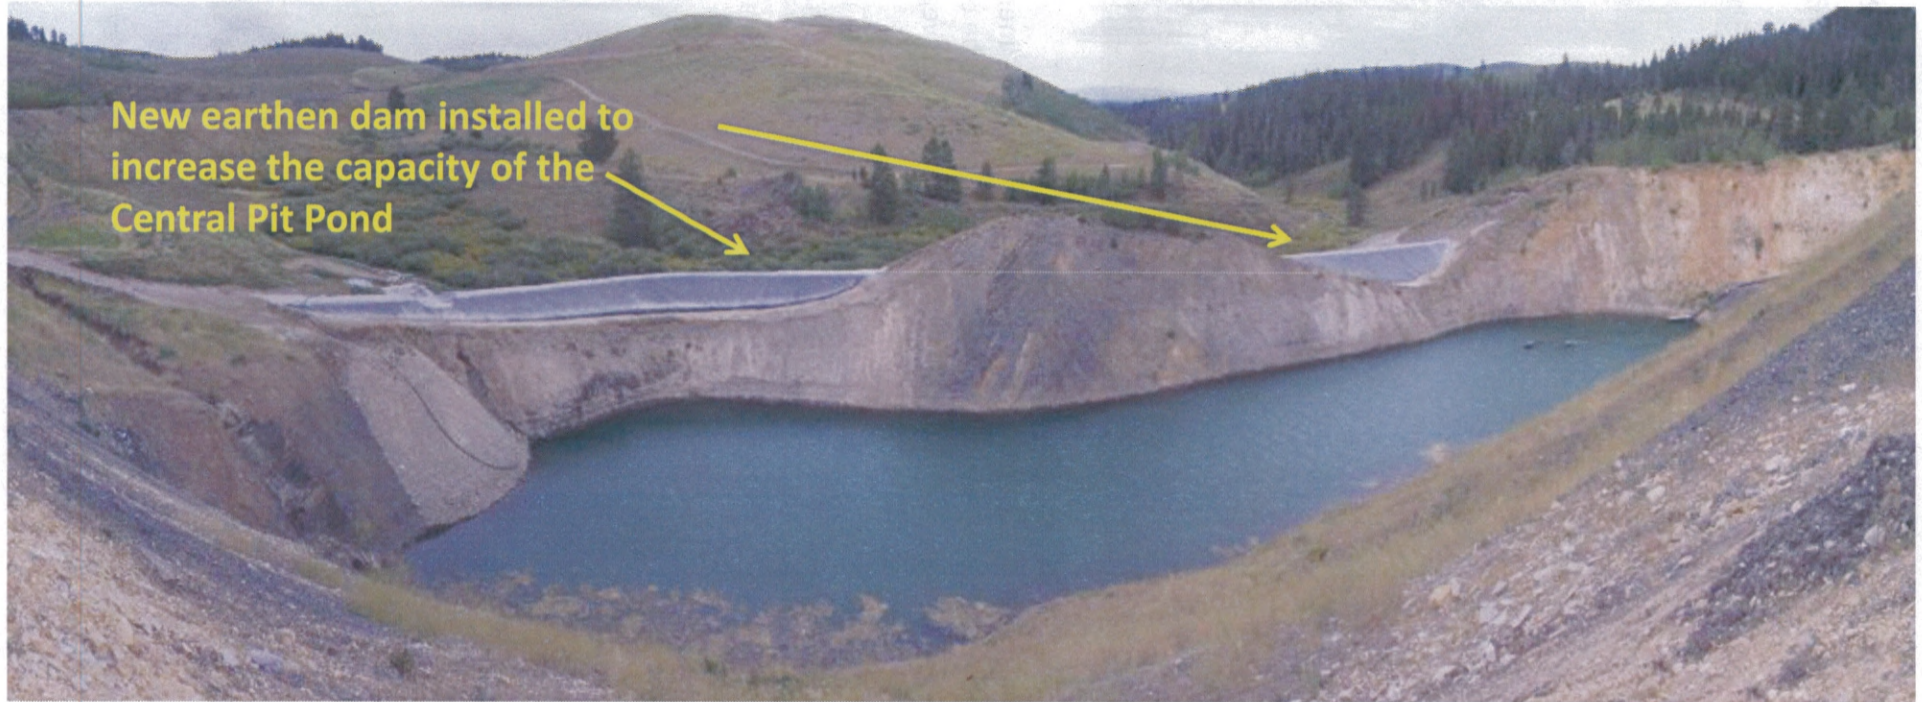
Photos No. 21 (Panoramic from photos R0011511-R0011514)  
The Central Pit Pond. Earth dams with an HDPE cover  
were installed to increase the capacity of the pond.

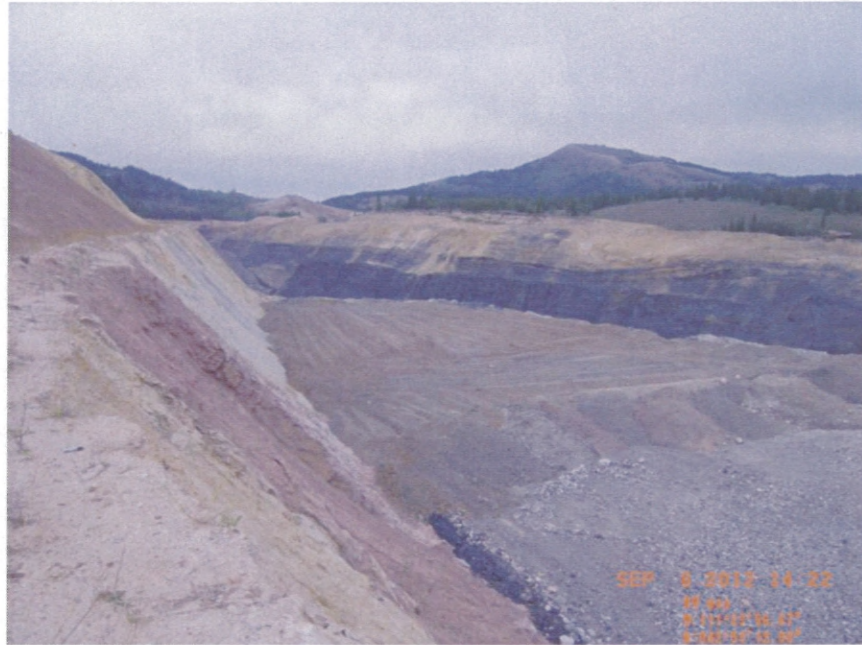
Photo No. 22 (R0011519)

Backfill from Panels A and B from of the currently active north section of the mine is being placed in northern part of the Central pit (view to the north).

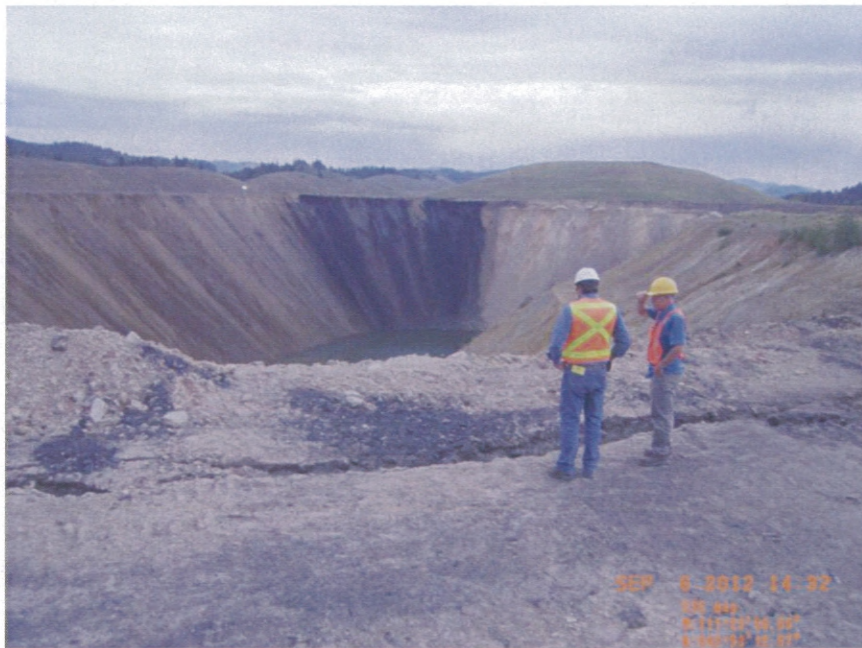
Photo No. 23 (R0011520)

Backfill from Panels A and B from of the currently active north section of the mine is being placed in northern part of the Central pit (view to the south).

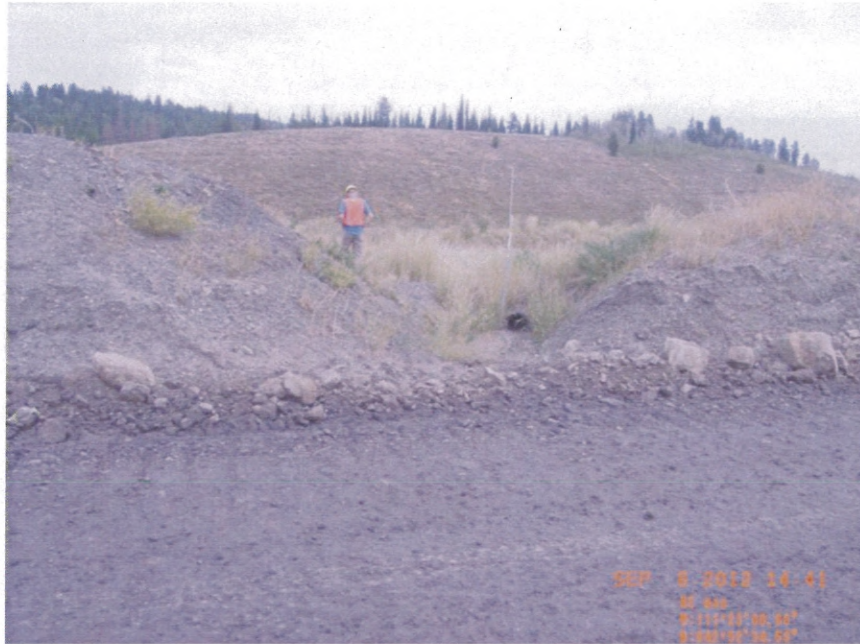
Photo No. 24 (R0011522)

Numerous ponds for collecting stormwater are located along the haul roads throughout the RRM. This culvert discharges to Pond 9, located on the east side of the haul road near the south end of the Central Pit.

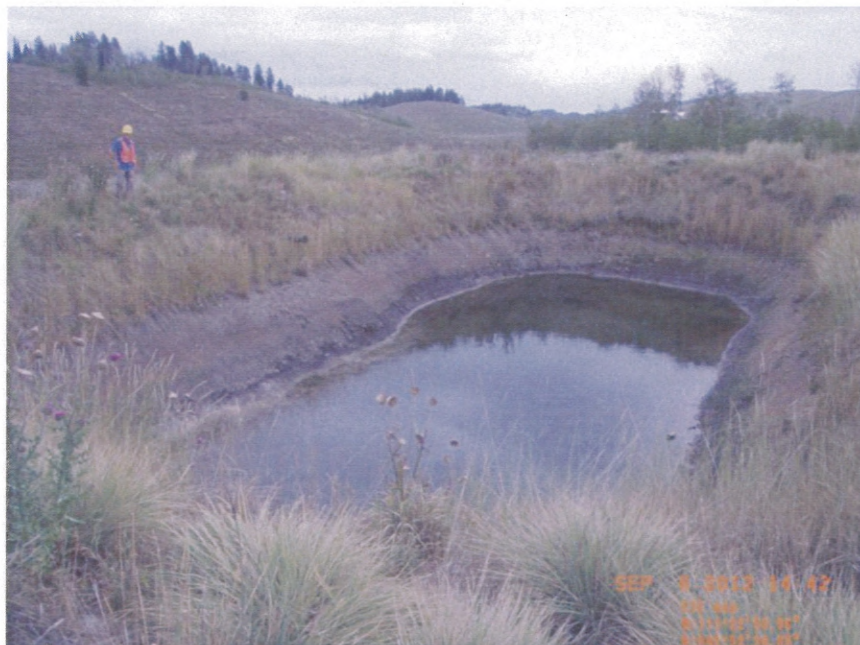
Photo No. 25 (R0011523)

Stormwater collection Pond 9.

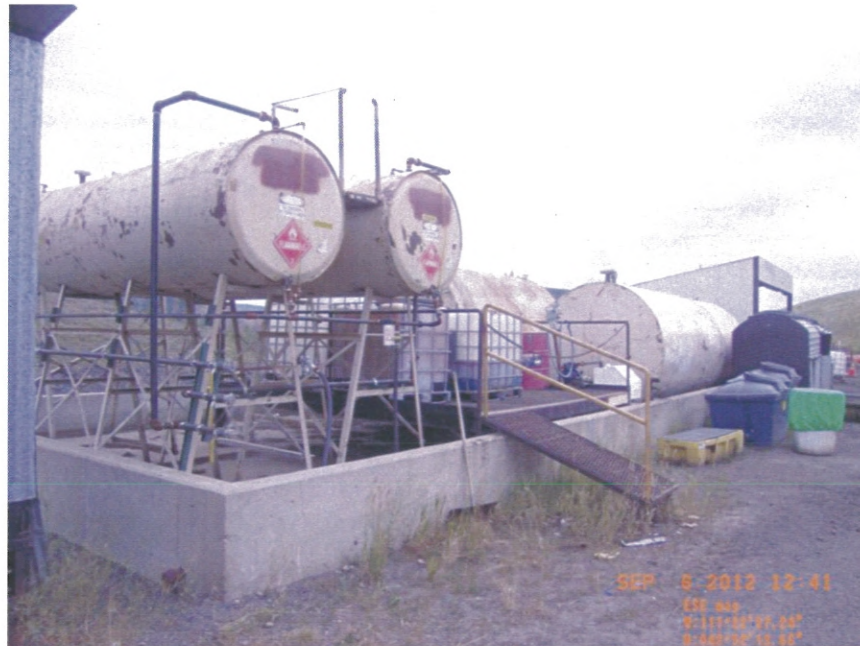
Photo No. 26 (R0011499)  
One of the fuel and chemical storage area at the shop/office complex.

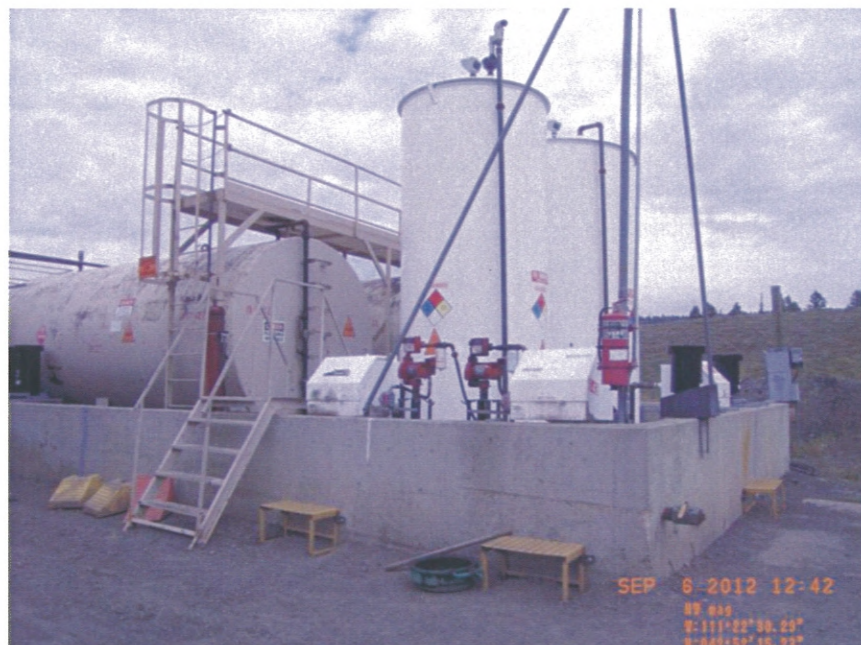
Photo No. 27 (R0011500)  
One of the fuel and chemical storage area at the shop/office complex.
